**Flood Control Project Maintenance
Levee Inspections****LMA District Cover Sheet****Spring 2014 Levee Inspection Results****Reclamation District No. 0785 Driver**

Levee Inspection Report By Mile - Spring 2014

Reclamation District No. 0785 Driver

Waterway	Bank	Unit Miles	Inspection Start/End	Inspector
Unit No. 01 Sacramento River	Right	2.31	03/27/2014 03/27/2014	John Williamson

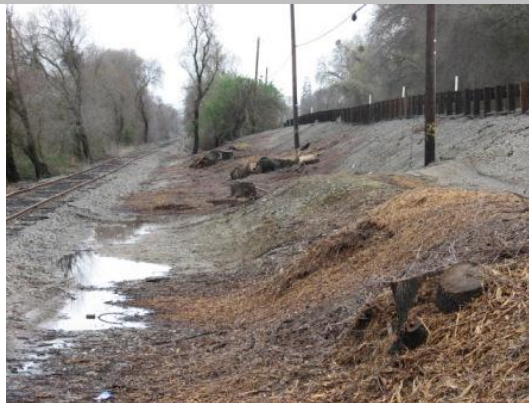
Photo 1 of 1 : johngw_s_20140306_946.jpg

LM Start	0.13	Rating **	N	Issue No.	4
LM End	1.36	Issue Type +	Ma	Location *	LS
Category	Earthen Levee			GPS Latitude/Longitude	
				Start	End
Item	Trim / Thin Trees			38.660160 °	38.646214 °
				-121.611619 °	-121.598596 °
DWR ID	DWR_RD0785_01_s _ 2012_4				
Action/Comments					
Tree stumps.

The trees were cut by PG&E's tree contractor. The district will take care of the stumps in the future.

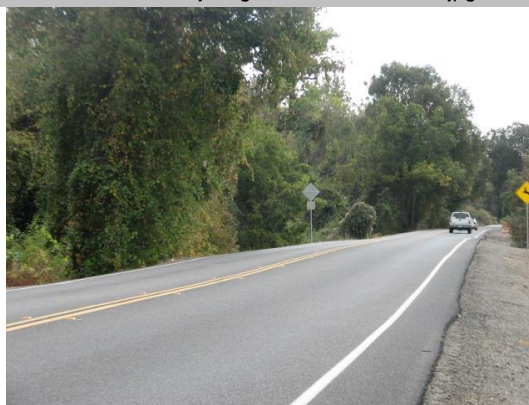
Photo 1 of 2 : johngw_s_20140306_954.jpg

LM Start	0.21	Rating **	M	Issue No.	16
LM End	1.37	Issue Type +	Ma	Location *	WS
Category	Earthen Levee			GPS Latitude/Longitude	
				Start	End
Item	Vegetation			38.659340 °	38.646093 °
				-121.610405 °	-121.598518 °
DWR ID	DWR_RD0785_01_f _ 2013_16				
Action/Comments					
Remove the wild growth other than native grasses from the levee slopes.

Brush and other vegetation partially blocks visibility or access to the levee slope. Fall 2013

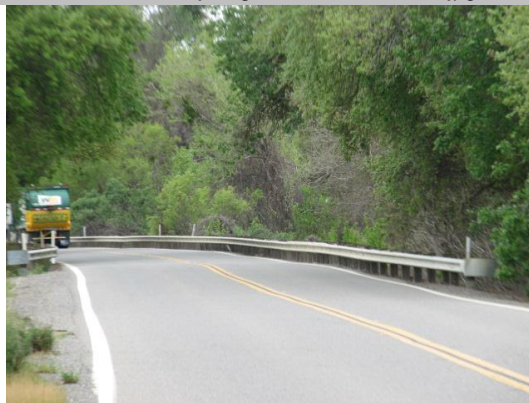
Photo 2 of 2 : johngw_s_20140401_702.jpg

Brush and other vegetation partially blocks visibility. Spring 2014

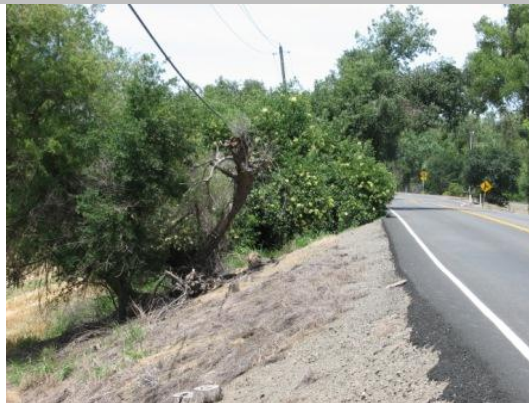
Photo 1 of 1 : johngw_s_20140306_944.jpg

LM Start	0.29	Rating **	A/W	Issue No.	1
LM End	0.29	Issue Type +	Ma	Location *	LS
Category	Earthen Levee			GPS Latitude/Longitude	
				Start	End
Item	Vegetation			38.658467 °	38.658467 °
				-121.609573 °	-121.609573 °
DWR ID	DWR_RD0785_01_s _ 2012_1				
Action/Comments					
Elderberries are blocking visibility and flood fight capability.

Elderberry

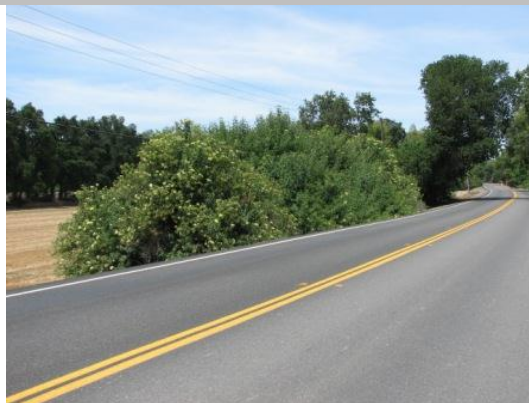
Photo 1 of 1 : johngw_s_20140306_945.jpg

LM Start	0.41	Rating **	A/W	Issue No.	2
LM End	0.45	Issue Type +	Ma	Location *	LS
Category	Earthen Levee			GPS Latitude/Longitude	
				Start	End
Item	Vegetation			38.657168 °	38.656697 °
				-121.608270 °	-121.607845 °
DWR ID	DWR_RD0785_01_s _ 2012_2				
Action/Comments					
Elderberries are blocking visibility and flood fight capability.

Elderberry

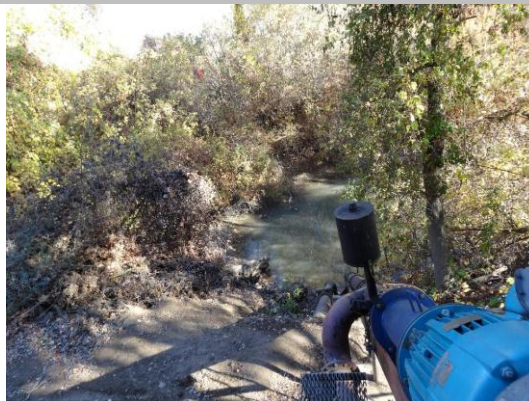
Photo 1 of 1 : UCIP_4559.jpg

LM Start	0.65	Rating **	M	Issue No.	180
LM End	0.65	Issue Type +	En	Location *	LS
Category	Supplemental			GPS Latitude/Longitude	
				Start	End
Item	DWR UCIP Field Study			38.654407 °	38.654407 °
				-121.605937 °	-121.605937 °
DWR ID	DWR_RD0785_01_s _ 2014_180				
Action/Comments					
Inspector Comments: FS_ID:25204					
EP_NO: N/A					
Repair Type:					
Crossing Status:					
UCIP Comments: Needs proper abandonment of pipe. No access to landside across the highway. A bigger pipe found on landside levee toe. It needs more info from LMA/Owner. Part of abandoned pipe also found on waterside.					
FIELD_STRUCT_DESC: 1 of 2: Abandoned 12-inch pipe through the levee, 11.0 feet below the crown. Pipes cross under highway fill and discharge into irrigation ditch.					
FS Date: 11/21/2013

WS view: two steel pipes on waterside. One of them was abandoned (top left).

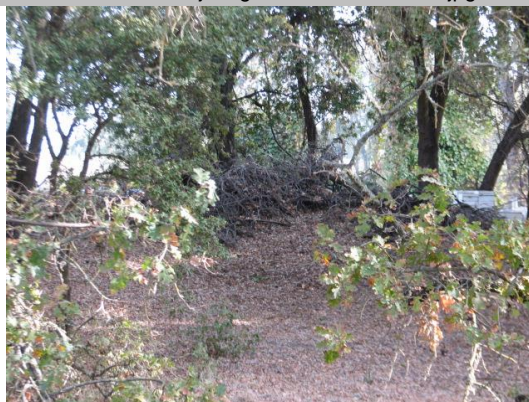
Photo 1 of 1 : johngw_s_20140306_955.jpg

LM Start	0.68	Rating **	M	Issue No.	46
LM End	0.68	Issue Type +	En	Location *	LS
Category	Earthen Levee			GPS Latitude/Longitude	
				Start	End
Item	Encroachments			38.653955 °	38.653955 °
				-121.605712 °	-121.605712 °
DWR ID	DWR_RD0785_01_s _ 2012_46				
Action/Comments					
Prunings

Pruning pile on the landside shoulder. Fall 2013

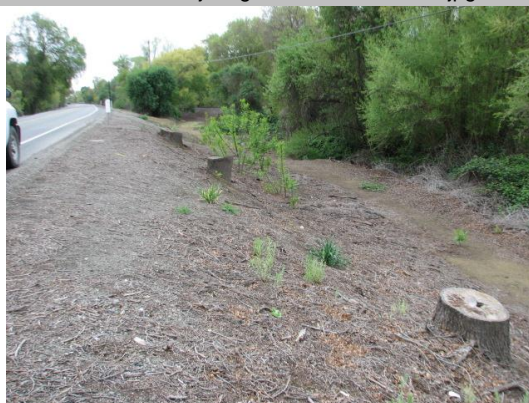
Photo 1 of 1 : johngw_s_20140401_699.jpg

LM Start	0.76	Rating **	N	Issue No.	181
LM End	0.76	Issue Type +	Ma	Location *	LS
Category	Earthen Levee			GPS Latitude/Longitude	
				Start	End
Item	Trim / Thin Trees			38.653003 °	38.653003 °
				-121.605061 °	-121.605061 °
DWR ID	DWR_RD0785_01_s _ 2014_181				
Action/Comments					
Tree stumps.

Tree stumps along the landside shoulder of the levee. Spring 2014

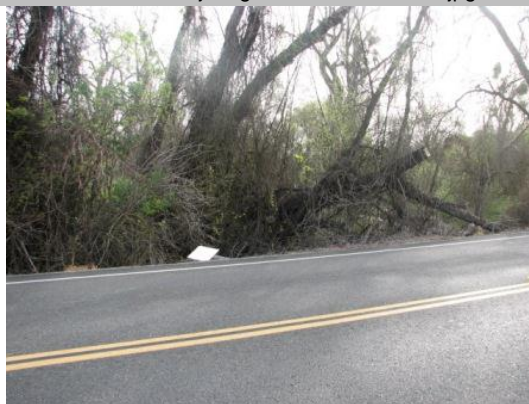
Photo 1 of 1 : johngw_s_20140306_956.jpg

LM Start	0.93	Rating **	M	Issue No.	47
LM End	0.93	Issue Type +	Ma	Location *	WS
Category	Earthen Levee			GPS Latitude/Longitude	
				Start	End
Item	Trim / Thin Trees			38.650992 °	38.650992 °
				-121.603392 °	-121.603392 °
DWR ID	DWR_RD0785_01_s _ 2012_47				
Action/Comments					
Trim and thin trees to allow visibility of the ground and room to flood fight.

The fallen tree and brush on the waterside of the roadway needs to be removed. Photo taken spring 2012.

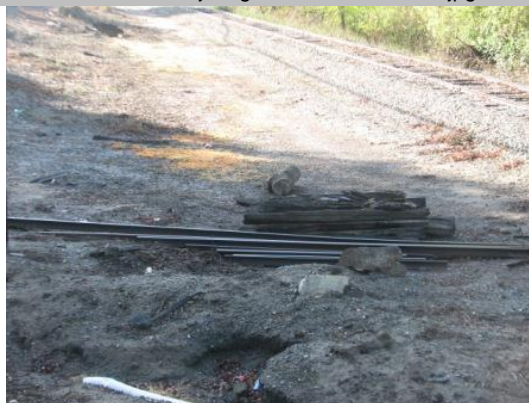
Photo 1 of 1 : johngw_s_20140306_951.jpg

LM Start	1.08	Rating **	M	Issue No.	12
LM End	1.08	Issue Type +	En	Location *	LS
Category	Earthen Levee			GPS Latitude/Longitude	
				Start	End
Item	Encroachments			38.649355 °	38.649355 °
				-121.601760 °	-121.601760 °
DWR ID	DWR_RD0785_01_s _ 2013_12				
Action/Comments					
Debris

Railroad ties and rails lay along the toe of the levee. Spring 2013

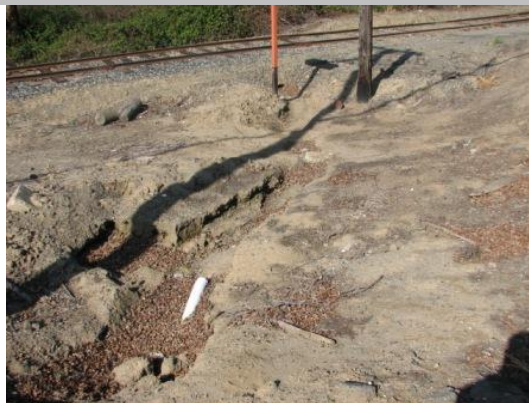
Photo 1 of 3 : johngw_s_20140306_957.jpg

LM Start	1.08	Rating **	M	Issue No.	48
LM End	1.08	Issue Type +	Ma	Location *	LS
Category	Earthen Levee			GPS Latitude/Longitude	
				Start	End
Item	Erosion / Bank Caving			38.649292 °	38.649292 °
				-121.601647 °	-121.601647 °
DWR ID	DWR_RD0785_01_s _ 2012_48				
Action/Comments					
Schedule repair of erosion site prior to the next inspection.

The drain pipe across from the firehouse has caused erosion, photo taken spring 2012.

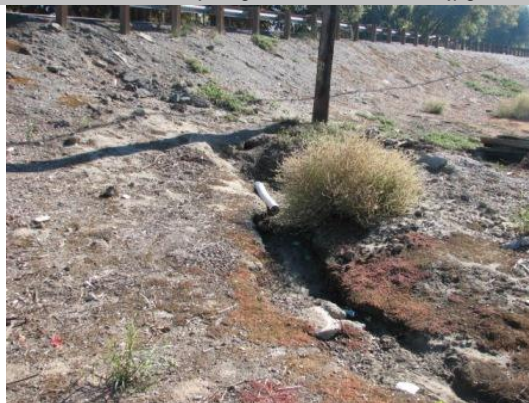
Photo 2 of 3 : johngw_s_20140306_958.jpg

Erosion on the levee slope and toe. Fall 2012

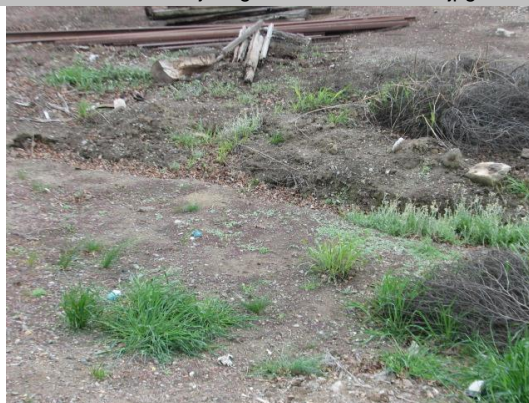
Photo 3 of 3 : johngw_s_20140401_700.jpg

LM Start	1.08	Rating **	M	Issue No.	48 (cont)
LM End	1.08	Issue Type +	Ma	Location *	LS
Category	Earthen Levee			GPS Latitude/Longitude	
				Start	End
Item	Erosion / Bank Caving			38.649292 °	38.649292 °
				-121.601647 °	-121.601647 °
DWR ID	DWR_RD0785_01_s _ 2012_48				
Action/Comments					
Schedule repair of erosion site prior to the next inspection.

Drain pipe is causing erosion on the landside of the levee between the slope and railroad tracks. Spring 2014

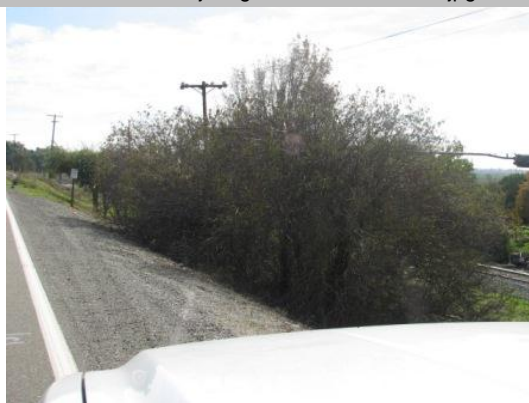
Photo 1 of 1 : johngw_s_20140306_947.jpg

LM Start	1.32	Rating **	A/W	Issue No.	6
LM End	1.32	Issue Type +	Ma	Location *	LS
Category	Earthen Levee			GPS Latitude/Longitude	
				Start	End
Item	Vegetation			38.646712 °	38.646712 °
				-121.599095 °	-121.599095 °
DWR ID	DWR_RD0785_01_s _ 2012_6				
Action/Comments					
Elderberries are blocking visibility and flood fight capability.

This is a very large Elderberry bush.

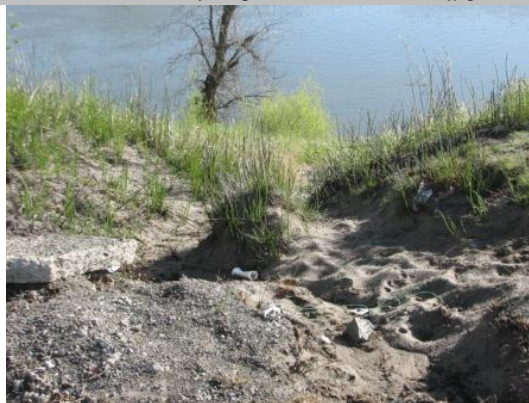
Photo 1 of 2 : johngw_s_20140306_952.jpg

LM Start	1.32	Rating **	M	Issue No.	13
LM End	1.32	Issue Type +	Ma	Location *	WS
Category	Earthen Levee			GPS Latitude/Longitude	
				Start	End
Item	Erosion / Bank Caving			38.646671 °	38.646671 °
				-121.598915 °	-121.598915 °
DWR ID	DWR_RD0785_01_s _ 2013_13				
Action/Comments					
Schedule repair of erosion site prior to the next inspection.

The waterside levee slope has erosion from surface run off. Spring 2013

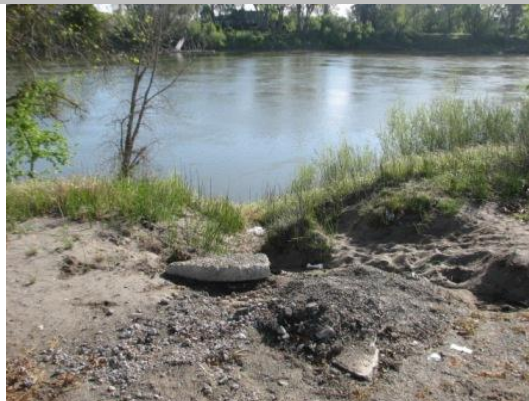
Photo 2 of 2 : johngw_s_20140306_953.jpg

LM Start	1.32	Rating **	M	Issue No.	13 (cont)	
LM End	1.32	Issue Type +	Ma	Location *	WS	
Category	Earthen Levee			GPS Latitude/Longitude		
				Start		End
Item	Erosion / Bank Caving			38.646671 °	38.646671 °	
				-121.598915 °	-121.598915 °	
DWR ID	DWR_RD0785_01_s _ 2013_13					
Action/Comments						
Schedule repair of erosion site prior to the next inspection.

The erosion has become a trail for fishermen and contributes to it.
Spring 2013

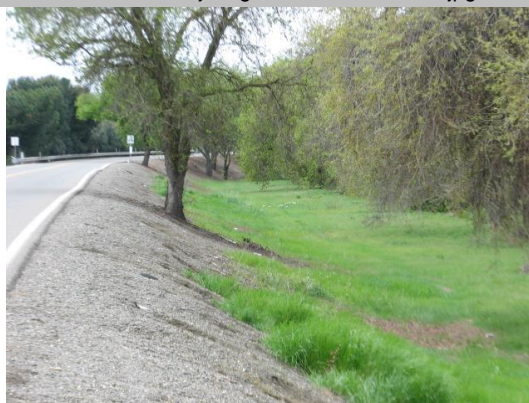
Photo 1 of 1 : johngw_s_20140401_701.jpg

LM Start	1.45	Rating **	M	Issue No.	182
LM End	2.30	Issue Type +	Ma	Location *	WS
Category	Earthen Levee			GPS Latitude/Longitude	
				Start	End
Item	Vegetation			38.645263 °	38.642976 °
				-121.597560 °	-121.584220 °
DWR ID	DWR_RD0785_01_s _ 2014_182				
Action/Comments					
Control annual grass and weeds on the levee slopes and easements.

Tall grasses, weeds partially blocks visibility. Spring 2014

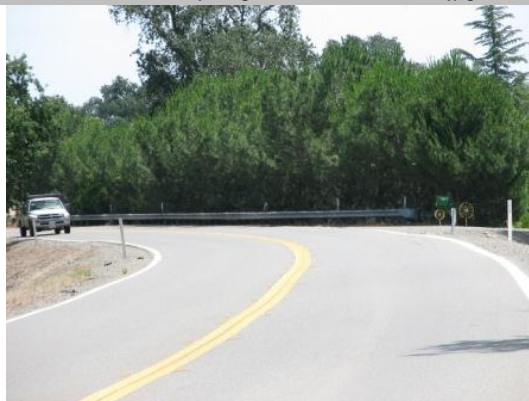
Photo 1 of 2 : johngw_s_20140306_948.jpg

LM Start	2.04	Rating **	M	Issue No.	8
LM End	2.14	Issue Type +	En	Location *	LS
Category	Earthen Levee			GPS Latitude/Longitude	
				Start	End
Item	Vegetation			38.641623 °	38.642005 °
				-121.588558 °	-121.586993 °
DWR ID	DWR_RD0785_01_s _ 2012_8				
Action/Comments					
Landscaping Inspector Comments: Trees have been raised for visibility. Pine trees and oleander planted on shoulder.

Pines and oleanders along shoulder.

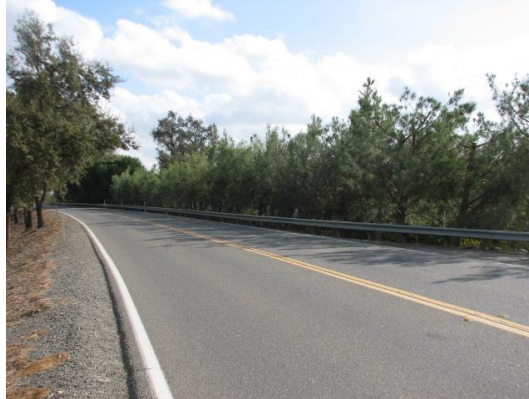
Photo 2 of 2 : johngw_s_20140306_949.jpg

LM Start	2.04	Rating **	M	Issue No.	8 (cont)
LM End	2.14	Issue Type +	En	Location *	LS
Category	Earthen Levee			GPS Latitude/Longitude	
				Start	End
Item	Vegetation			38.641623 °	38.642005 °
				-121.588558 °	-121.586993 °
DWR ID	DWR_RD0785_01_s _ 2012_8				
Action/Comments					
Landscaping Inspector Comments: Trees have been raised for visibility. Pine trees and oleander planted on shoulder.

The pine trees along the shoulder have been topped and thin out.
Oleanders still on the shoulder. Fall 2013

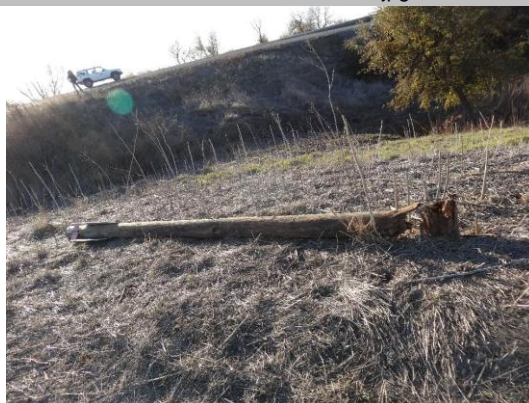
Photo 1 of 1 : UCIP_4204.jpg

LM Start	0.00	Rating **	M	Issue No.	141
LM End	0.00	Issue Type +	En	Location *	WS
Category	Supplemental			GPS Latitude/Longitude	
				Start	End
Item	DWR UCIP Field Study			38.641085 °	38.641085 °
				-121.620349 °	-121.620349 °
DWR ID	DWR_RD0785_02_s_2014_141				
Action/Comments					
Inspector Comments: FS_ID:24750					
EP_NO: 16982					
Repair Type:					
Crossing Status:					
UCIP Comments: Only a damaged indicator post found on landside across the road. Damaged indicator needs to be fixed.					
FIELD_STRUCT_DESC: Three 2-inch-diameter and three 1.5-inch diameter HDPE conduits containing fiber optic cables across and under the east levee (County Road 124), 67 feet below the crown. HDPE pipes were pulled through an 8-inch bore hole and backfilled with bentonite. (App. No. 16982 - Pacific Fiber Link)					
FS Date: 12/2/2013

LS view: damaged indicator post across the levee road.

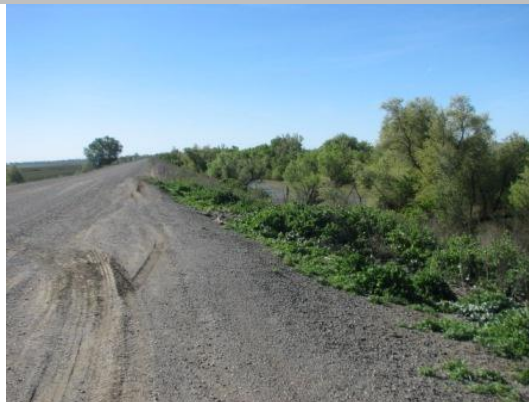
Photo 1 of 3 : johngw_s_20140306_960.jpg

LM Start	0.01	Rating **	M	Issue No.	2
LM End	3.29	Issue Type +	Ma	Location *	WS
Category	Earthen Levee			GPS Latitude/Longitude	
				Start	End
Item	Vegetation			38.640913 °	38.599586 °
				-121.620295 °	-121.590301 °
DWR ID	DWR_RD0785_02_f_2012_2				
Action/Comments					
Control annual grass and weeds on the levee slopes and easements.

The vegetation is taller than 12". Spring 2013

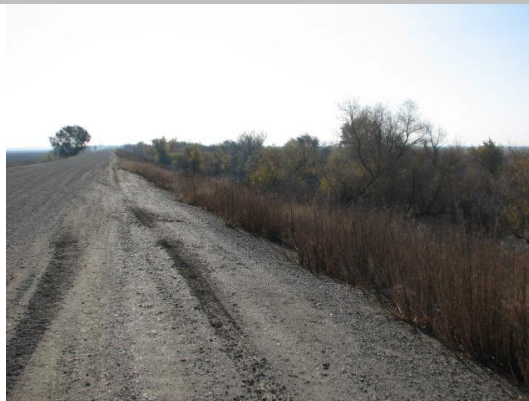
Photo 2 of 3 : johngw_s_20140306_961.jpg

Tall weeds block visibility of the levee slope. Fall 2013

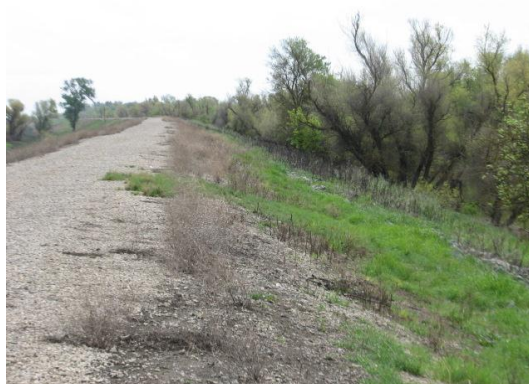
Photo 3 of 3 : johngw_s_20140401_704.jpg

Tall grasses, weeds partially blocks visibility. Spring 2014

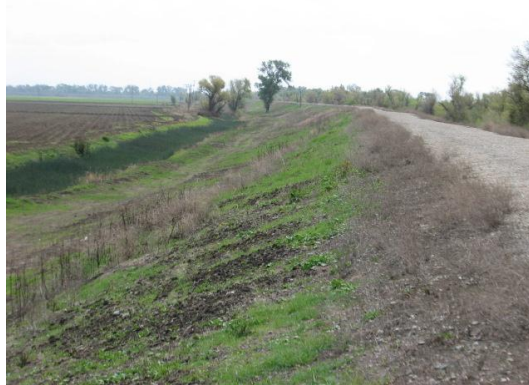
Photo 1 of 1 : johngw_s_20140401_703.jpg

LM Start	0.01	Rating **	M	Issue No.	142
LM End	3.29	Issue Type +	Ma	Location *	LS
Category	Earthen Levee			GPS Latitude/Longitude	
				Start	End
Item	Vegetation			38.640913 °	38.599585 °
				121.620300 °	-121.590301 °
DWR ID	DWR_RD0785_02_s_2014_142				
Action/Comments					
Control annual grass and weeds on the levee slopes and easements.

Tall grasses, weeds partially blocks visibility. Spring 2014

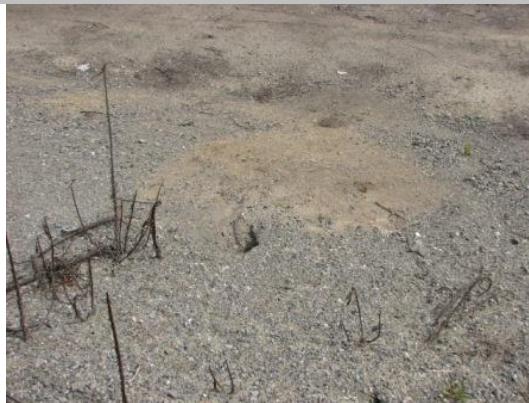
Photo 1 of 1 : johngw_s_20140306_963.jpg

Rodent holes on the landside levee slope, photo taken spring 2012.

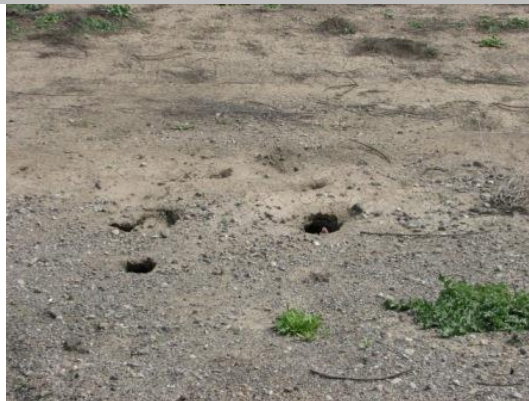
Photo 1 of 1 : johngw_s_20140306_964.jpg

Rodent holes on the landside levee slope, photo taken spring 2012.

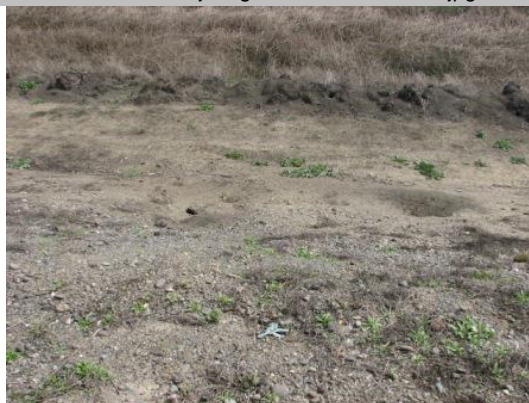
Photo 1 of 2 : johngw_s_20140306_965.jpg

Rodent holes on the landside levee slope, photo taken spring 2012.

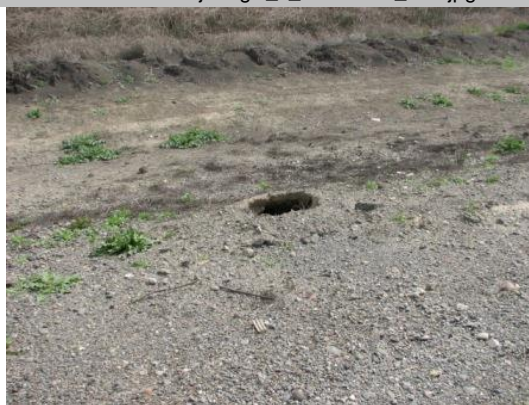
Photo 2 of 2 : johngw_s_20140306_966.jpg

Many rodent holes with in 25' of each other, photo taken spring 2012.

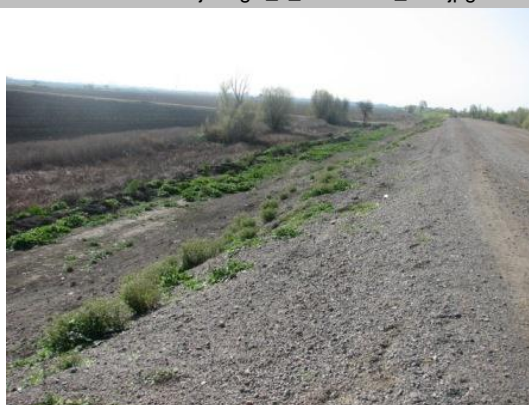
Photo 1 of 2 : johngw_s_20140306_967.jpg

LM Start	0.52	Rating **	M	Issue No.	29
LM End	0.52	Issue Type +	Ma	Location *	LS
Category	Earthen Levee			GPS Latitude/Longitude	
				Start	End
Item	Slope Stability			38.634180 °	38.634180 °
				-121.616142 °	-121.616142 °
DWR ID	DWR_RD0785_02_s _ 2012_29				
Action/Comments					
Repair slope instability.

Bulge at the landside toe of the levee, photos taken spring 2012.

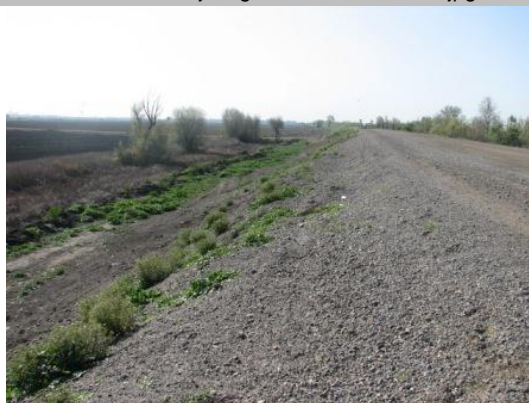
Photo 2 of 2 : johngw_s_20140306_968.jpg

LM Start	0.52	Rating **	M	Issue No.	29 (cont)	
LM End	0.52	Issue Type +	Ma	Location *	LS	
Category	Earthen Levee			GPS Latitude/Longitude		
				Start		End
Item	Slope Stability			38.634180 °		38.634180 °
				-121.616142 °		-121.616142 °
DWR ID	DWR_RD0785_02_s _ 2012_29					
Action/Comments						
Repair slope instability.

Slope instability at shoulder of landside levee buldge at toe.

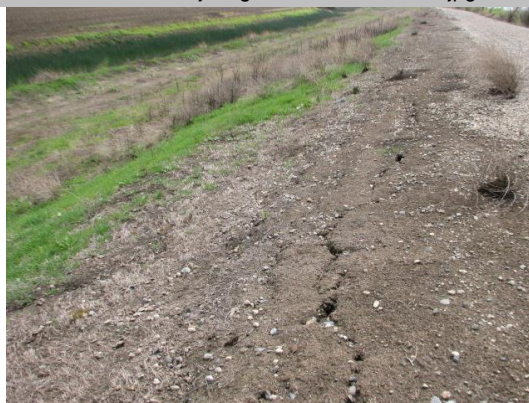
Photo 1 of 1 : johngw_s_20140401_705.jpg

LM Start	0.87	Rating **	M	Issue No.	143
LM End	0.87	Issue Type +	Ma	Location *	LS
Category	Earthen Levee			GPS Latitude/Longitude	
				Start	End
Item	Slope Stability			38.629693 °	38.629693 °
				-121.613436 °	-121.613436 °
DWR ID	DWR_RD0785_02_s _ 2014_143				
Action/Comments					
Repair slope instability.

Cracking along the shoulder causing slope instability. Spring 2014

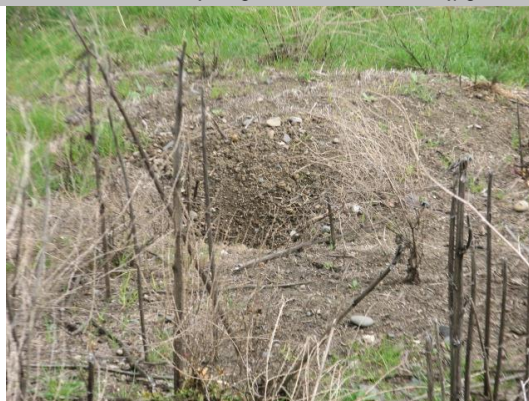
Photo 1 of 1 : johngw_s_20140401_706.jpg

LM Start	0.87	Rating **	M	Issue No.	42
LM End	0.90	Issue Type +	Ma	Location *	LS
Category	Earthen Levee			GPS Latitude/Longitude	
				Start	End
Item	Animal Control			38.629589 °	38.629259 °
				-121.613372 °	-121.613156 °
DWR ID	DWR_RD0785_02_s _ 2014_42				
Action/Comments					
No rodents visible, but rodent burrows visible; need to backfill and compact or grout burrows.

Large rodent hole close to the toe of the levee. Spring 2014

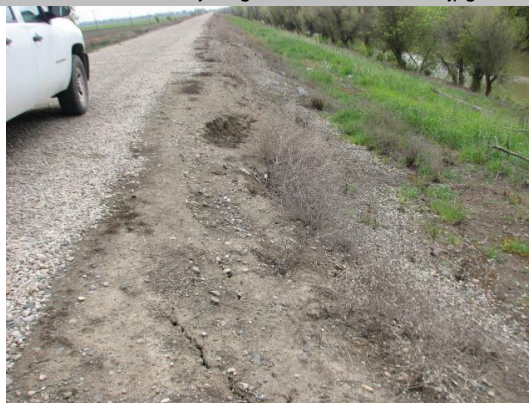
Photo 1 of 1 : johngw_s_20140401_707.jpg

LM Start	1.10	Rating **	M	Issue No.	144
LM End	1.10	Issue Type +	Ma	Location *	WS
Category	Earthen Levee			GPS Latitude/Longitude	
				Start	End
Item	Slope Stability			38.626676 °	38.626676 °
				-121.611325 °	-121.611325 °
DWR ID	DWR_RD0785_02_s _ 2014_144				
Action/Comments					
Repair slope instability.

Slope instability along the waterside shoulder. Spring 2014

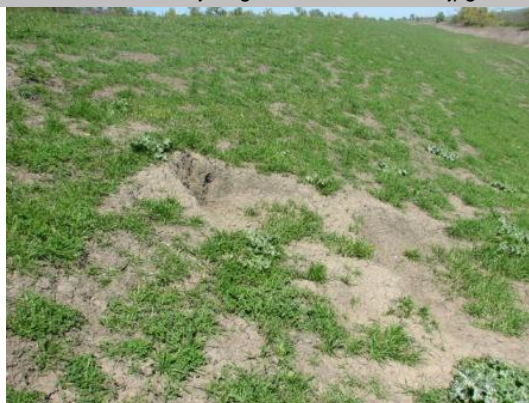
Photo 1 of 4 : johngw_s_20140306_969.jpg

LM Start	2.18	Rating **	M	Issue No.	30
LM End	2.18	Issue Type +	Ma	Location *	LS
Category	Earthen Levee			GPS Latitude/Longitude	
				Start	End
Item	Slope Stability			38.613104 °	38.613104 °
				-121.600915 °	-121.600915 °
DWR ID	DWR_RD0785_02_s _ 2012_30				
Action/Comments					
Repair slope instability.

There is slope instability with three step like spots. The cuts are 1' to 1.5' deep. Photo taken spring 2012.

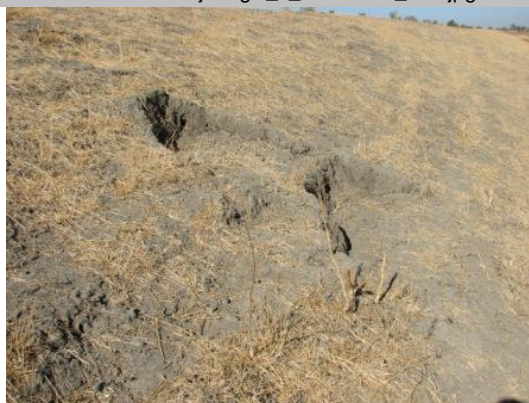
Photo 2 of 4 : johngw_s_20140306_970.jpg

Slope instability. Photo fall 2012.

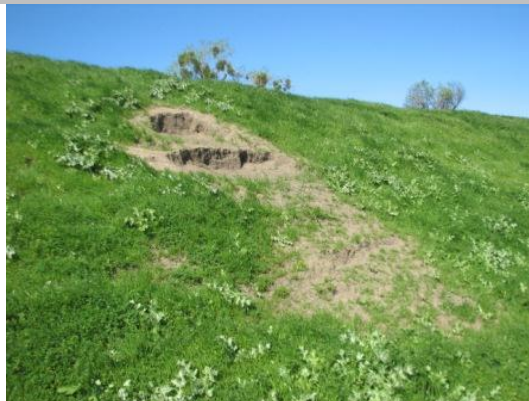
Photo 3 of 4 : johngw_s_20140306_971.jpg

LM Start	2.18	Rating **	M	Issue No.	30 (cont)	
LM End	2.18	Issue Type +	Ma	Location *	LS	
Category	Earthen Levee			GPS Latitude/Longitude		
				Start		End
Item	Slope Stability			38.613104 °		38.613104 °
				-121.600915 °		-121.600915 °
DWR ID	DWR_RD0785_02_s _ 2012_30					
Action/Comments						
Repair slope instability.

Slope instability is still there. Spring 2013

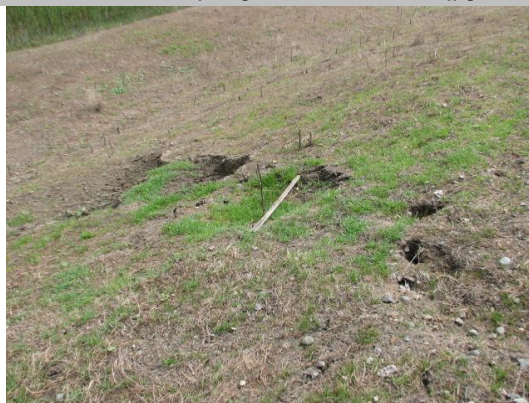
Photo 4 of 4 : johngw_s_20140401_708.jpg

Current view of the slope instability. Spring 2014

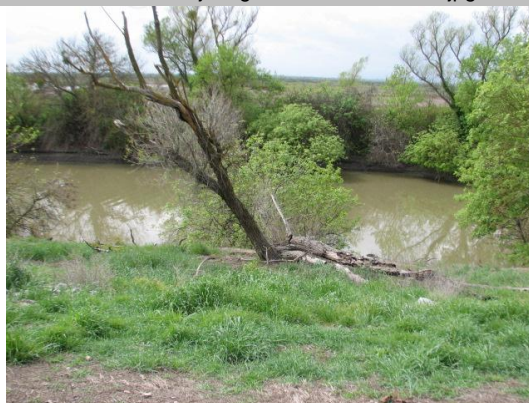
Photo 1 of 1 : johngw_s_20140401_709.jpg

LM Start	2.99	Rating **	M	Issue No.	56
LM End	2.99	Issue Type +	En	Location *	WS
Category	Earthen Levee			GPS Latitude/Longitude	
				Start	End
Item	Encroachments			38.603222 °	38.603222 °
				-121.593231 °	-121.593231 °
DWR ID	DWR_RD0785_02_s _ 2014_56				
Action/Comments					
Tree or limb

Discarded branches lay at the toe of the levee. The trees is about to fall over and may cause damage to the levee. Spring 2014
